Concealed Bike Anti-Theft Device

Elizabeth Atkinson, Alex Wen, Srinidhi Raman ECE 445 Spring 2022

Bike Unit: Control Subsystem

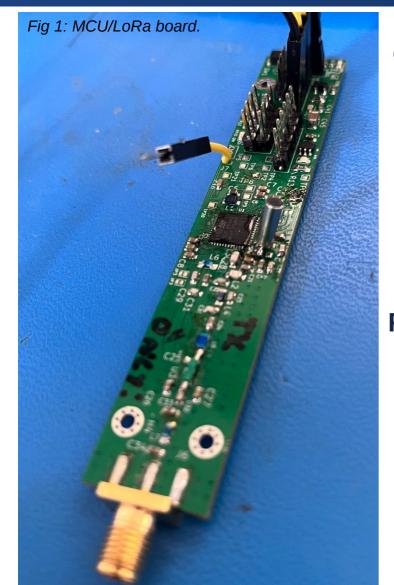
- STM32WLCC integrated microcontroller and SubGHz transceiver
- Dual core Cortex-m4/Cortex-m0

- The microcontroller implements a state-based control system with power saving measures in the idle/safe states.
- The microcontroller packetizes GPS data to be sent over LoRa.

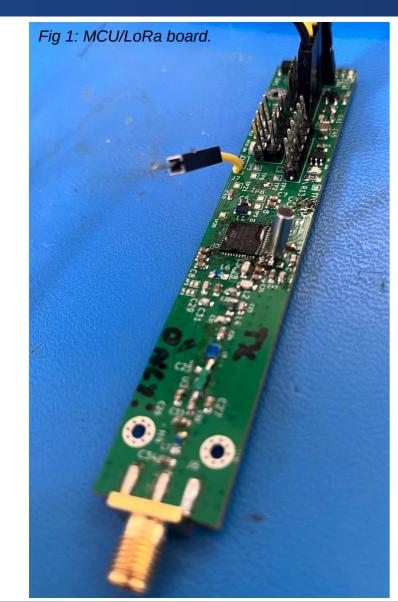
- Based on the STM32WL55CC integrated microcontroller and transceiver
- Firmware uses the ST low-level radio driver

- The LoRa Subsystem matching network and antenna have a VSWR of less than 10 at the RF output of the STM32WL55CC.
- The antenna is hidden in a common bike component so that it is not visibly obvious.

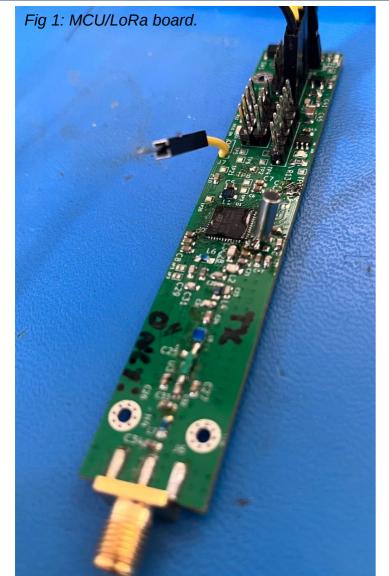
- Able to implement the STprovide low-level radio driver.
- Radio driver code successfully transmitted on the STMWL Nucleo dev board (Fig 1).

Unable to transmit using LoRa on the PCB we designed. For a detailed engineering explanation of the suspected cause, refer to Appendix 2. Fig 2: TX with nucleo board; note the frequency is 430 MHz. The nucleos are tuned for the 400-MHz band so we could not use them for LoRa which uses the 915 MHz band.

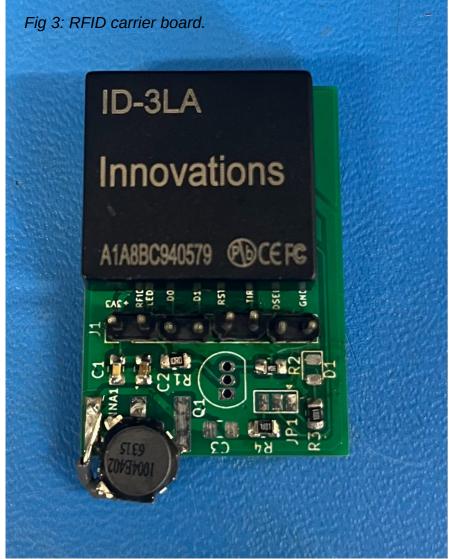
- Based around the ID-3LA RFID Module and external 1mH antena
- Communicates with microcontroller over UART

- The RFID detector will detect the user's RFID tag within 10 seconds.
- The RFID subsystem will provide a visual indicator that the RFID tag has been detected within 1 second of detecting the RFID tag.
- The RFID subsystem triggers the alarm if movement occurs and the user's RFID has not been detected.
- The RFID indicator detector LED is concealed in an unobtrusive location on the bike.

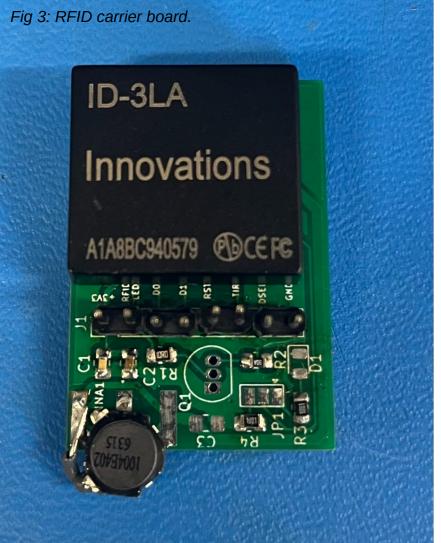
• Since the antenna was very small, the range was very low (<10 cm). In the future, a larger antenna could increase the range.
